March 8, 2019

Reference: **Report of Asbestos and Lead-Based Paint Surveys**
215 Bonview Avenue
Lincolnton, North Carolina

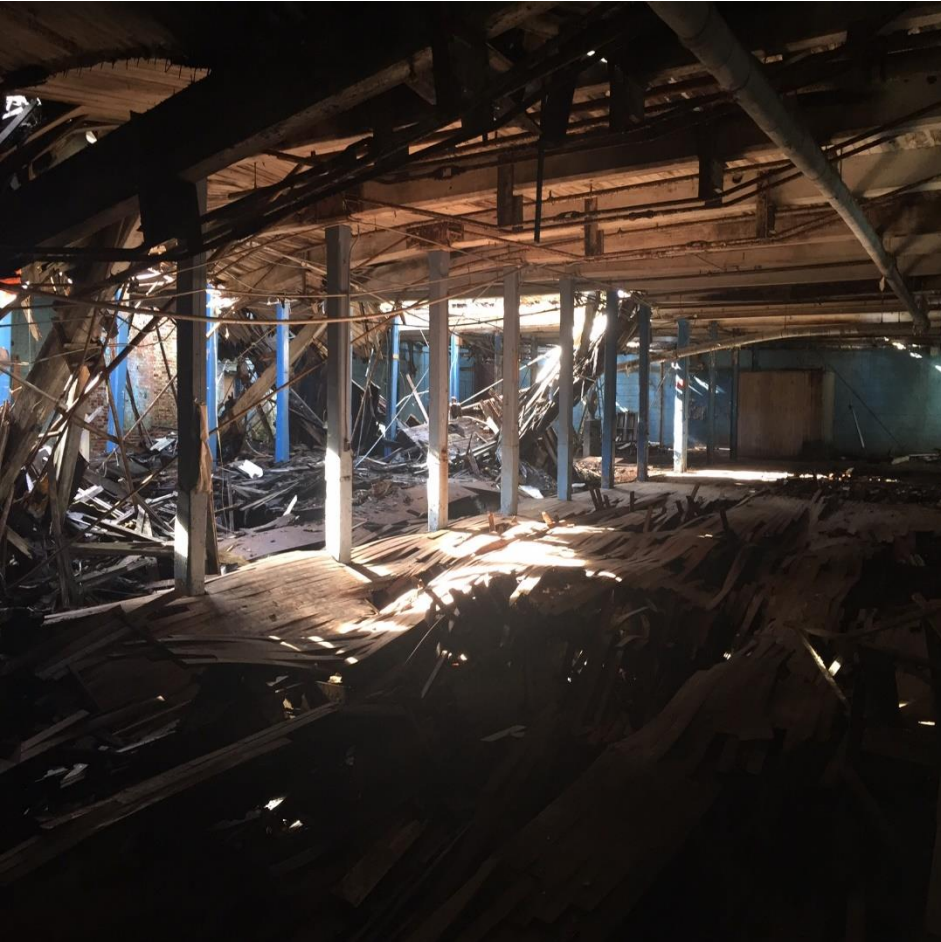
Photo 17 – Collapsed ceiling/floor area on ground floor

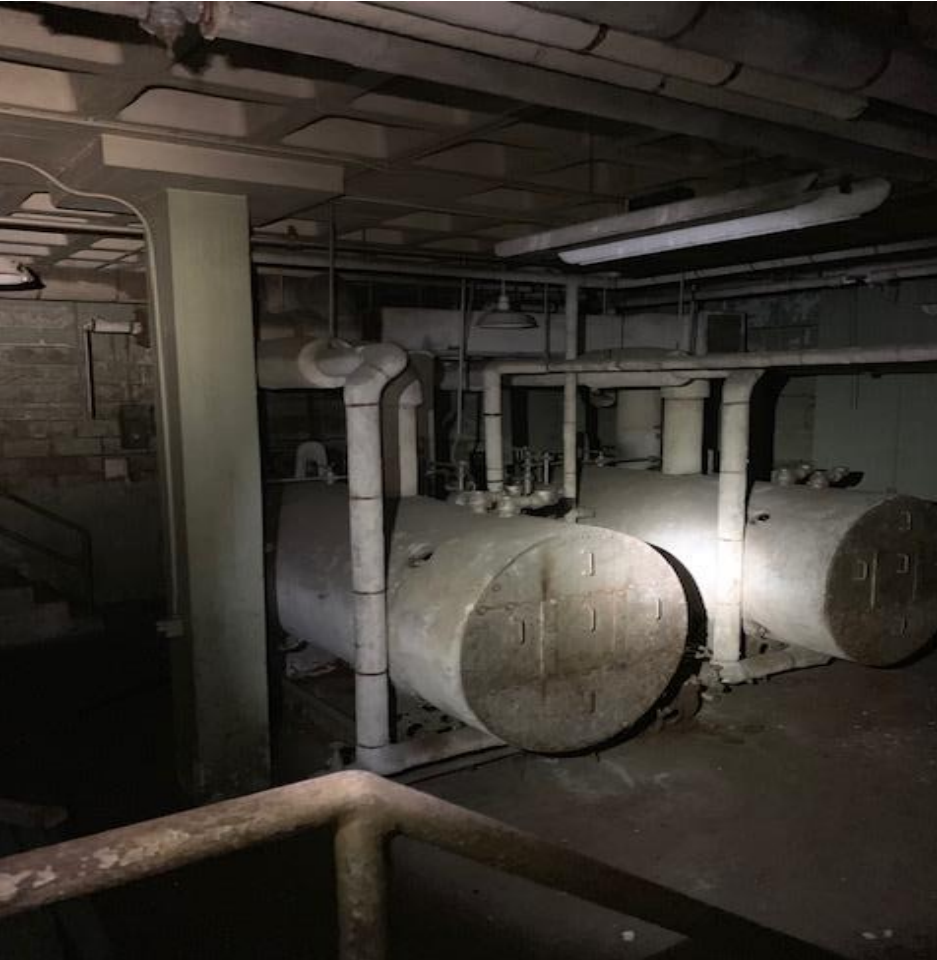
Photo 1– View of Boiler Room in SE Corner of Basement

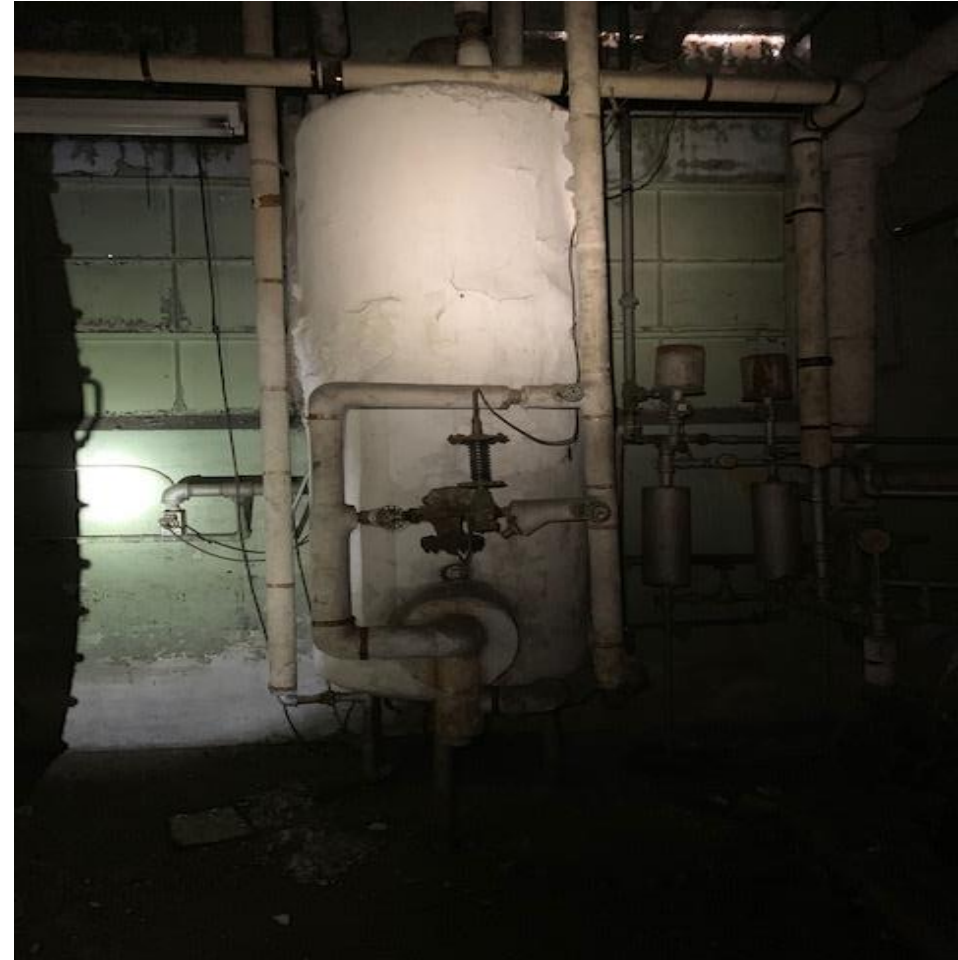
Photo 2– Hot Water Tank in Boiler Room

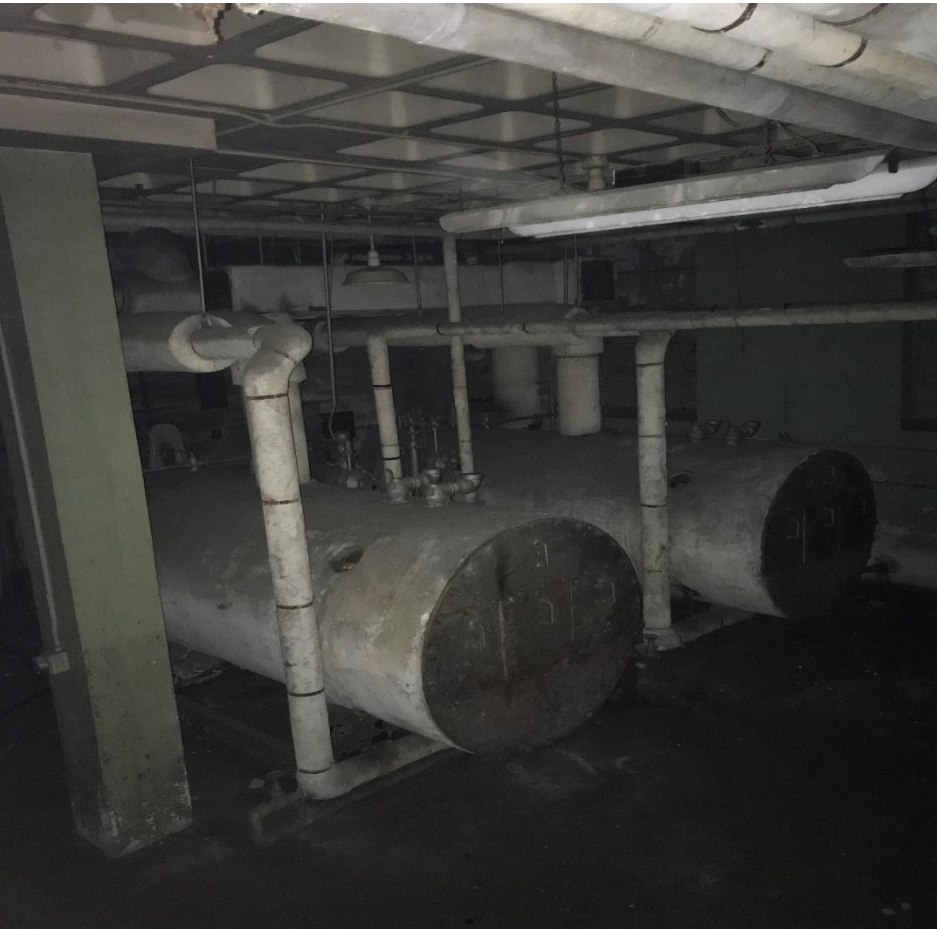
Photo 3 – Layout of SE Basement Boiler Room

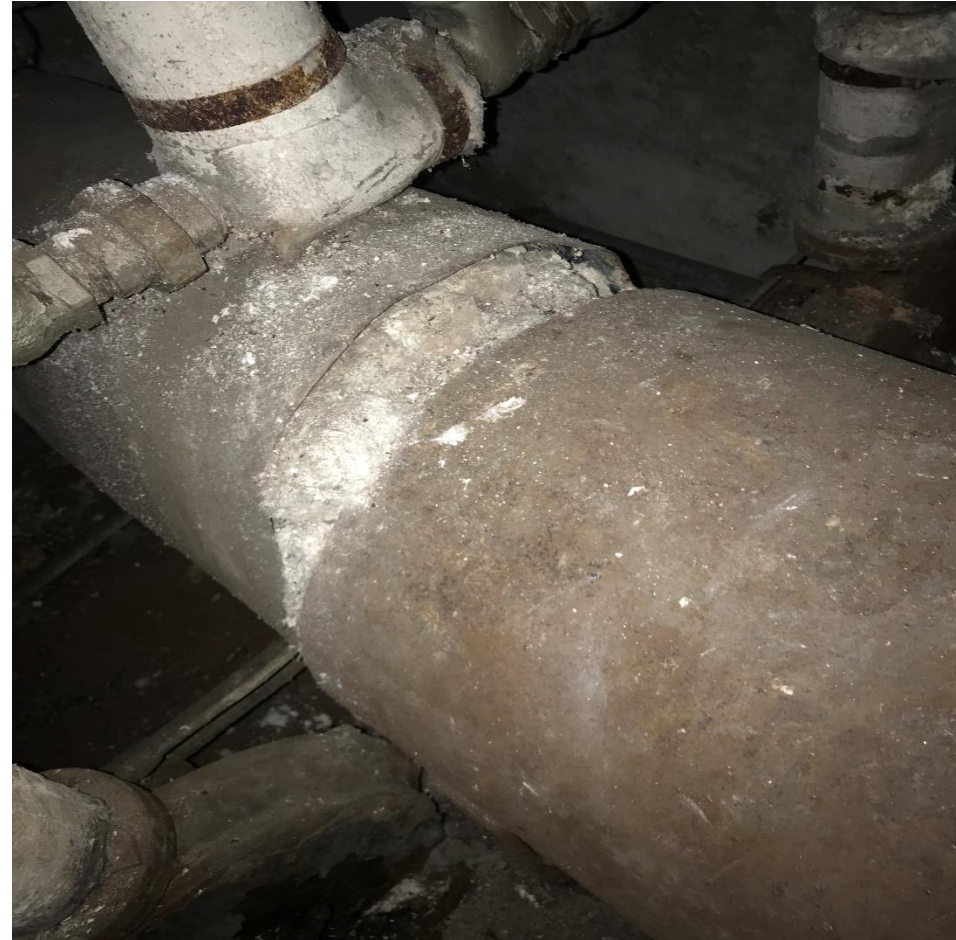
Photo 4 – Encased Pipe Insulation in SE Basement Boiler Room

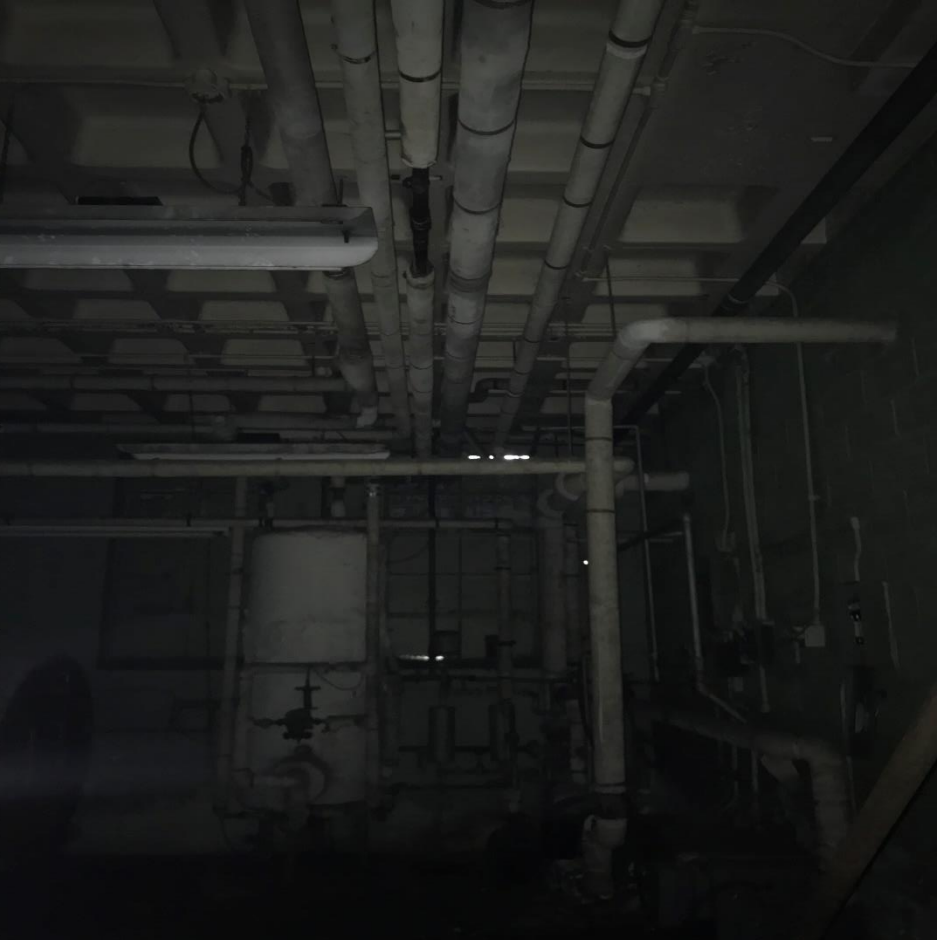
Photo 5 – Pipe Runs in SE Corner Boiler Room in Basement

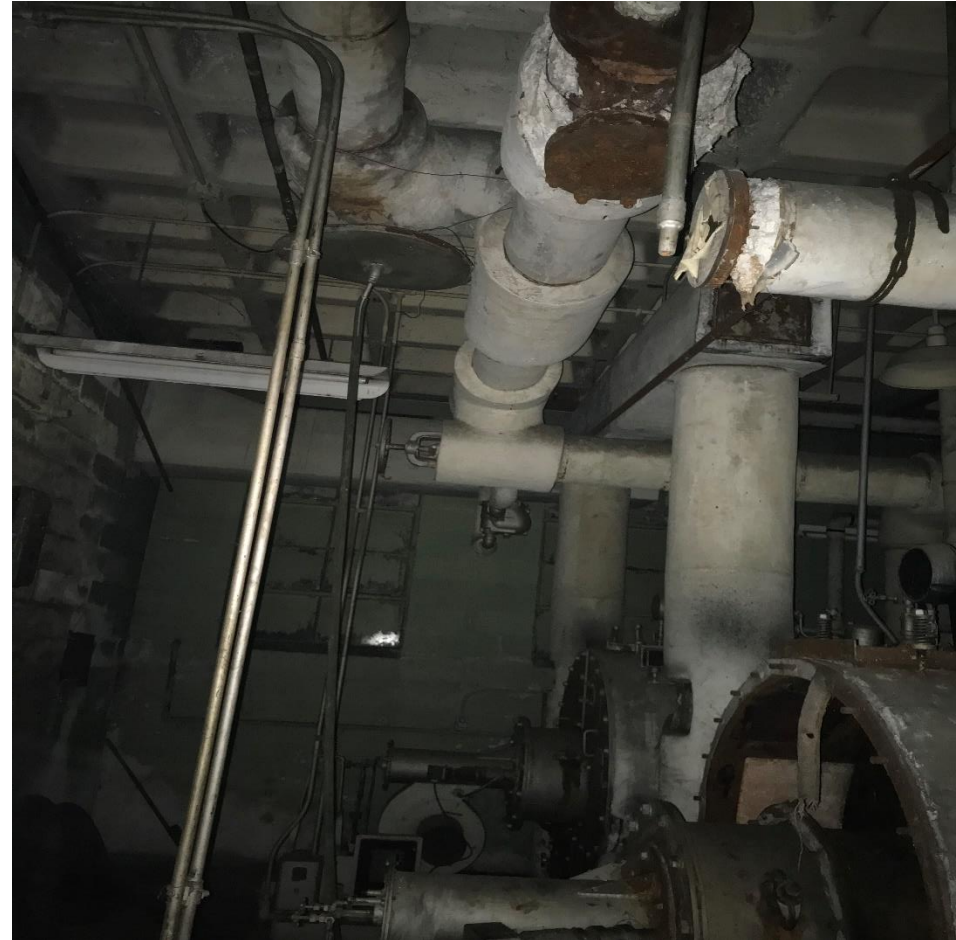
Photo 6 – SE Basement Corner Pipe Insulation in Boiler Room

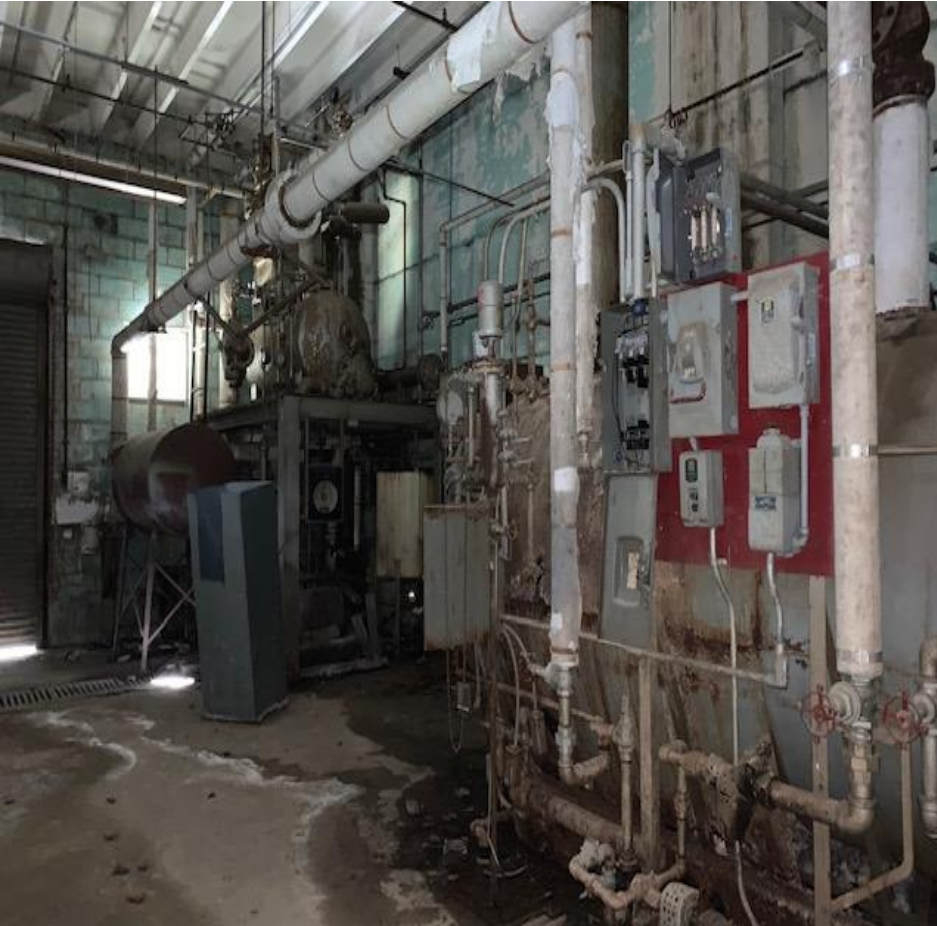
Photo 7 – Pipe Runs and Boilers in SW Corner of Basement

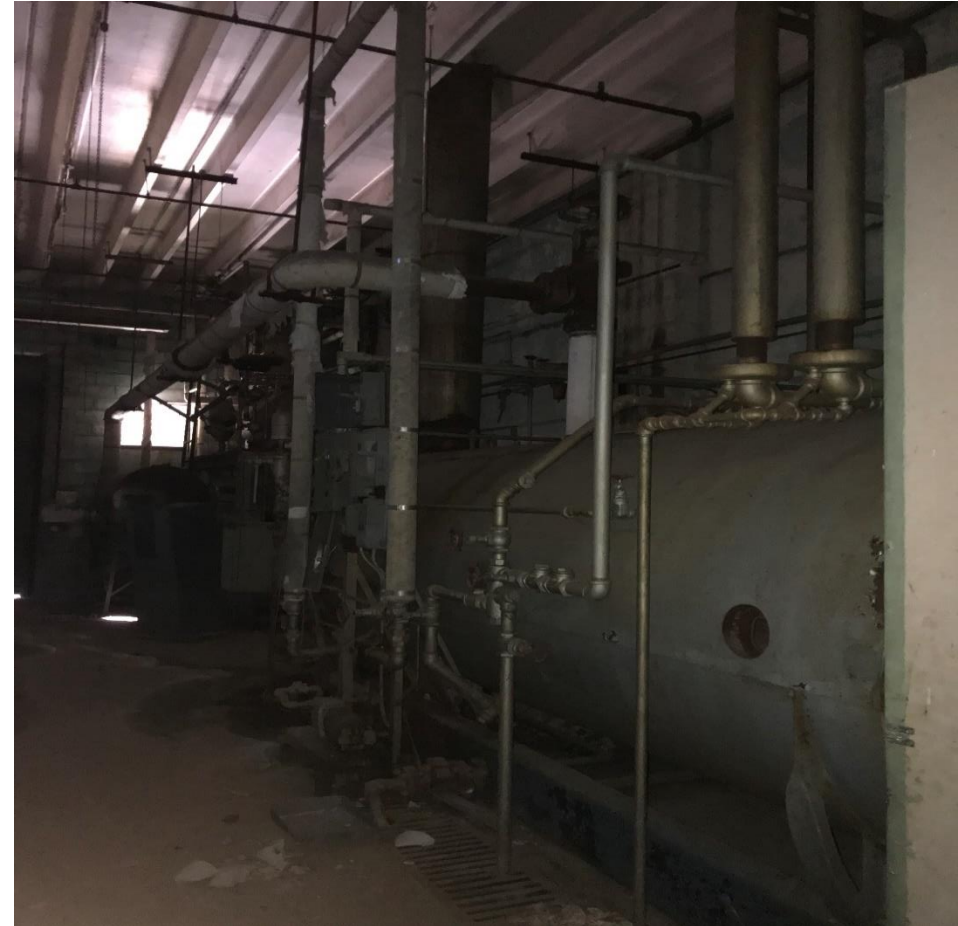
Photo 8 – Pipe Runs and Boilers in SW Corner of Basement cont.

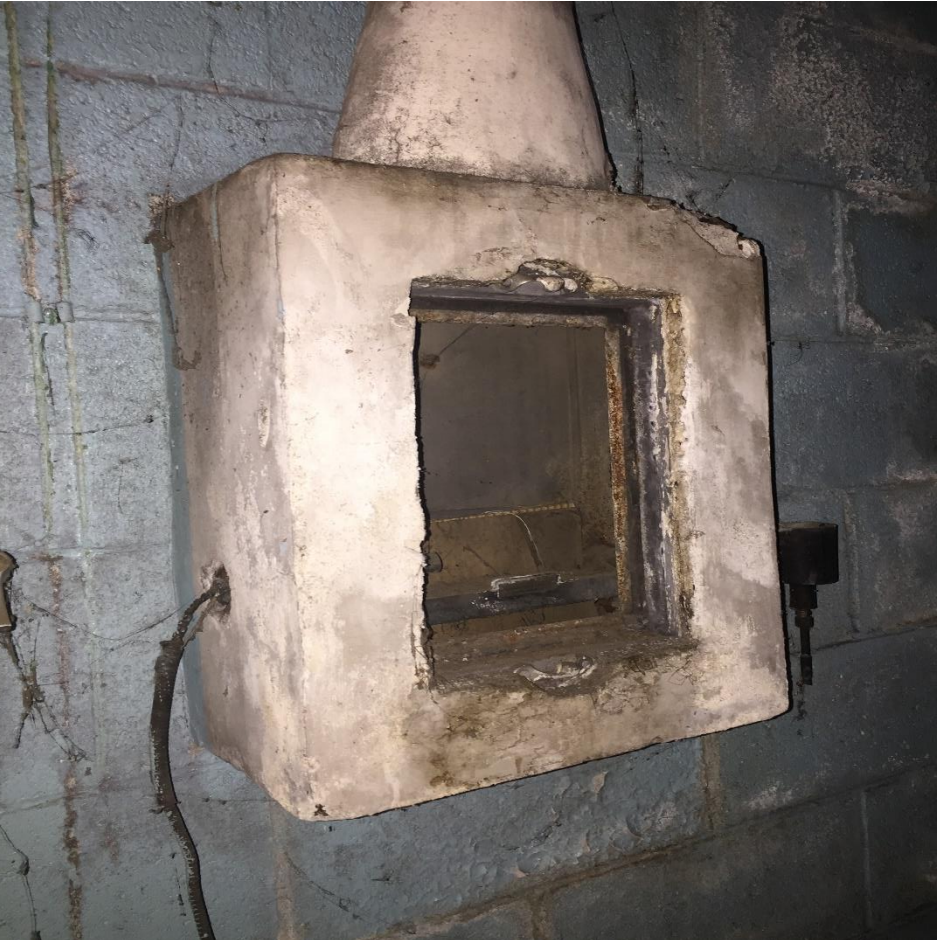
Photo 9 – Insulated Box in Ground Floor HVAC Room

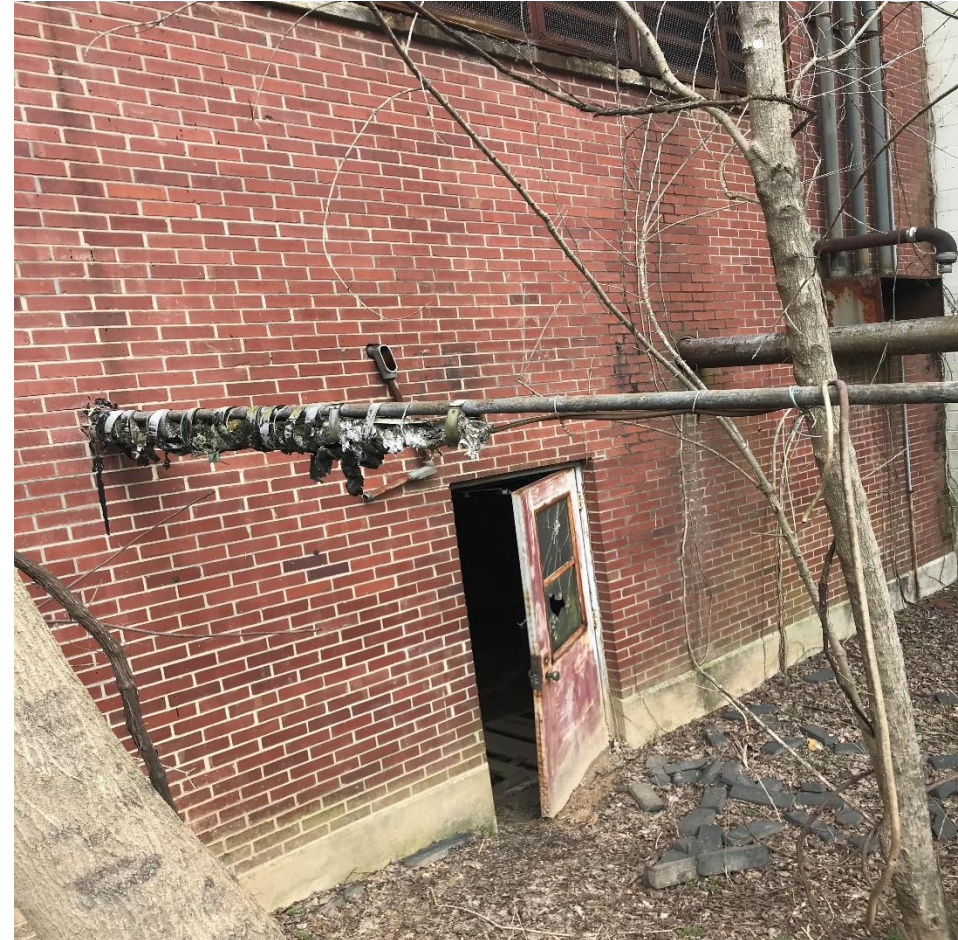
The asbestos-containing white block pipe insulation, wall panel insulation, electrical box insulation, insulating boards and tank/boiler insulation are considered friable materials in fair to poor condition. The asbestos-containing vinyl floor tile and built-up roofing are considered Category I non-friable materials in poor condition. The black mastic, paint and tar on the foam-glass pipe insulation are Category II non-friable materials in fair condition. The identified ACM should be removed by a qualified asbestos-abatement contractor prior to activities which may disturb the materials. In addition, a large quantity of insulation has fallen off the pipes and onto the soil of the crawlspace. This soil is assumed to be contaminated with asbestos-containing pipe insulation. The soil should not be disturbed until an asbestos abatement design is developed and implemented. The design may include encapsulation or removal of the soil.

Photo 10 – Poor Condition Pipe Insulation Running to Outside of Basement

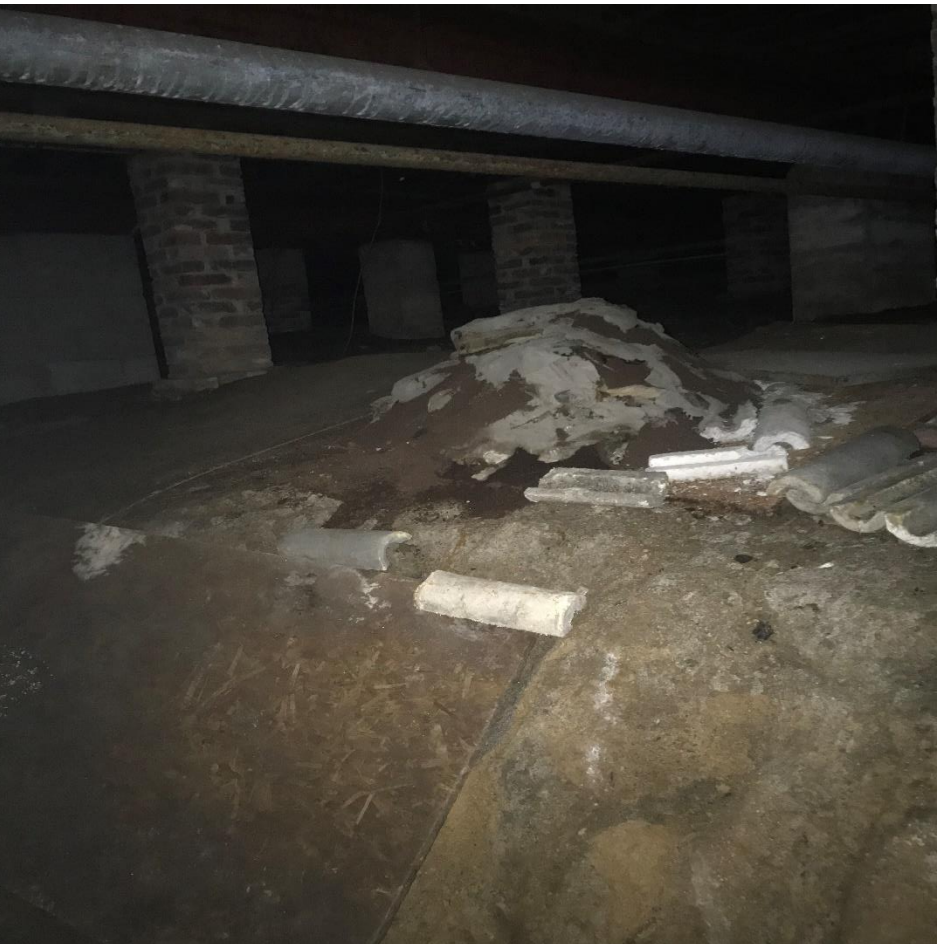
Photo 11 – Poor Condition Delaminated Pipe Insulation on Crawlspace Dirt

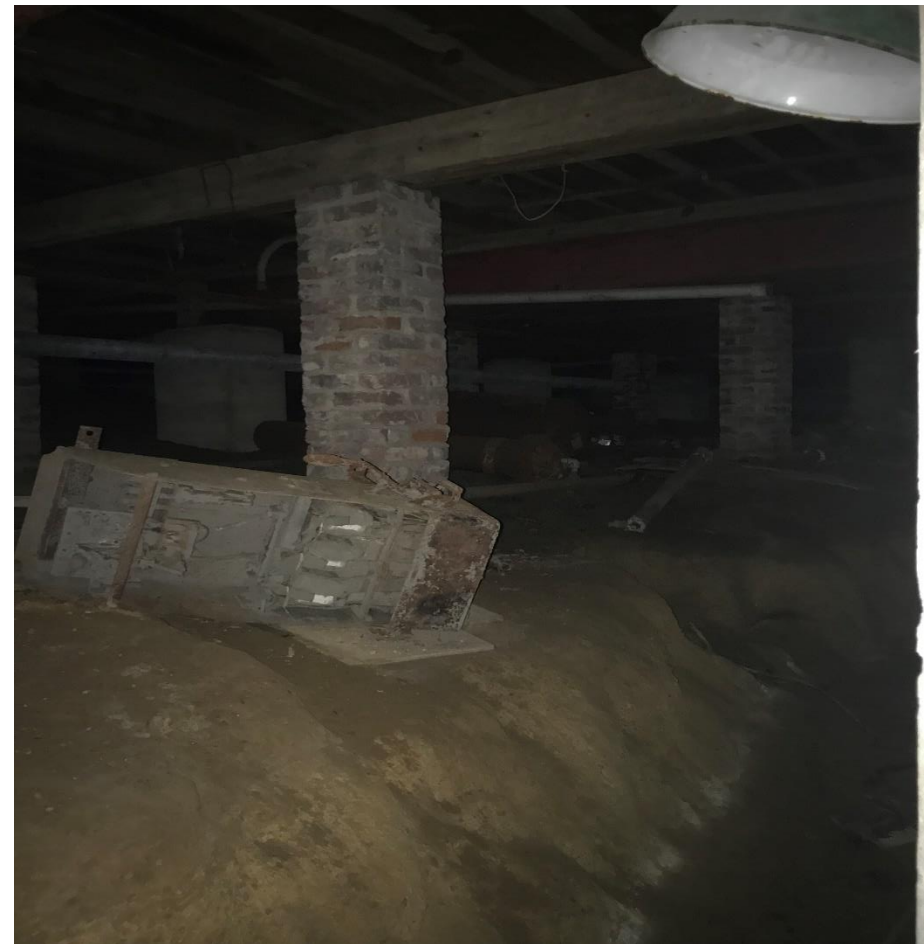
Photo 12 – Asbestos Pipe Insulation on Crawlspace Dirt

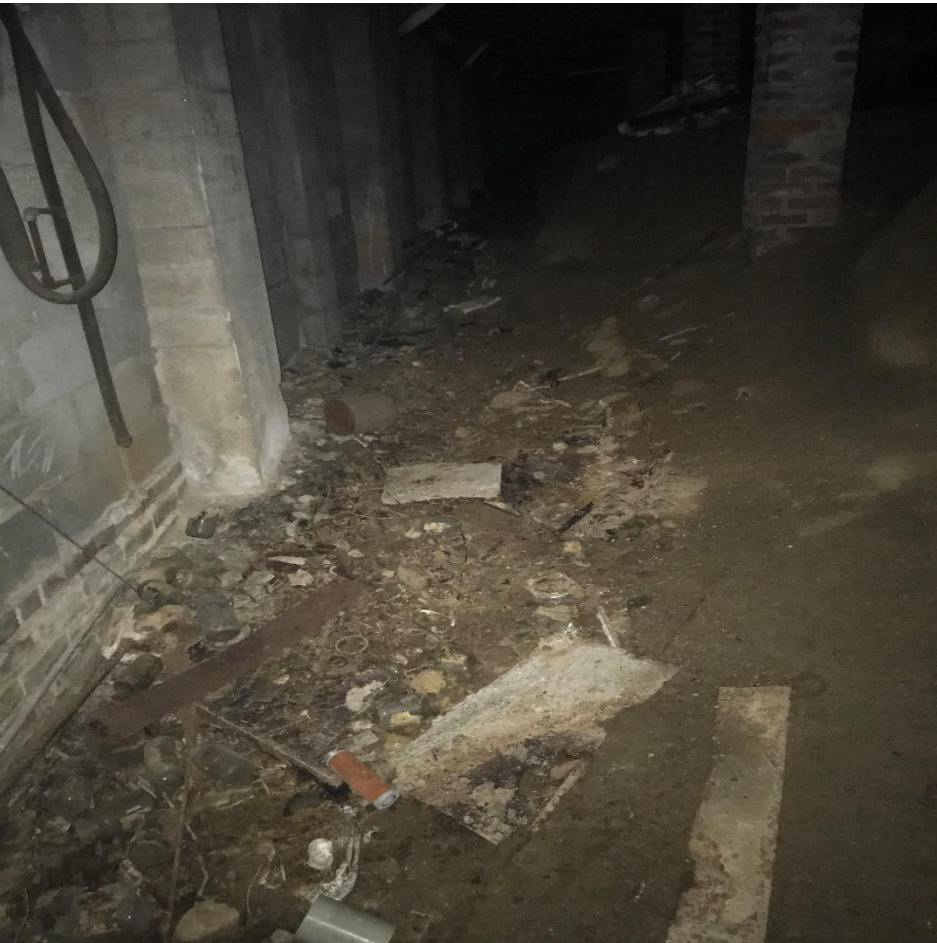
Photo 13 – Contaminated Soil in Crawlspace

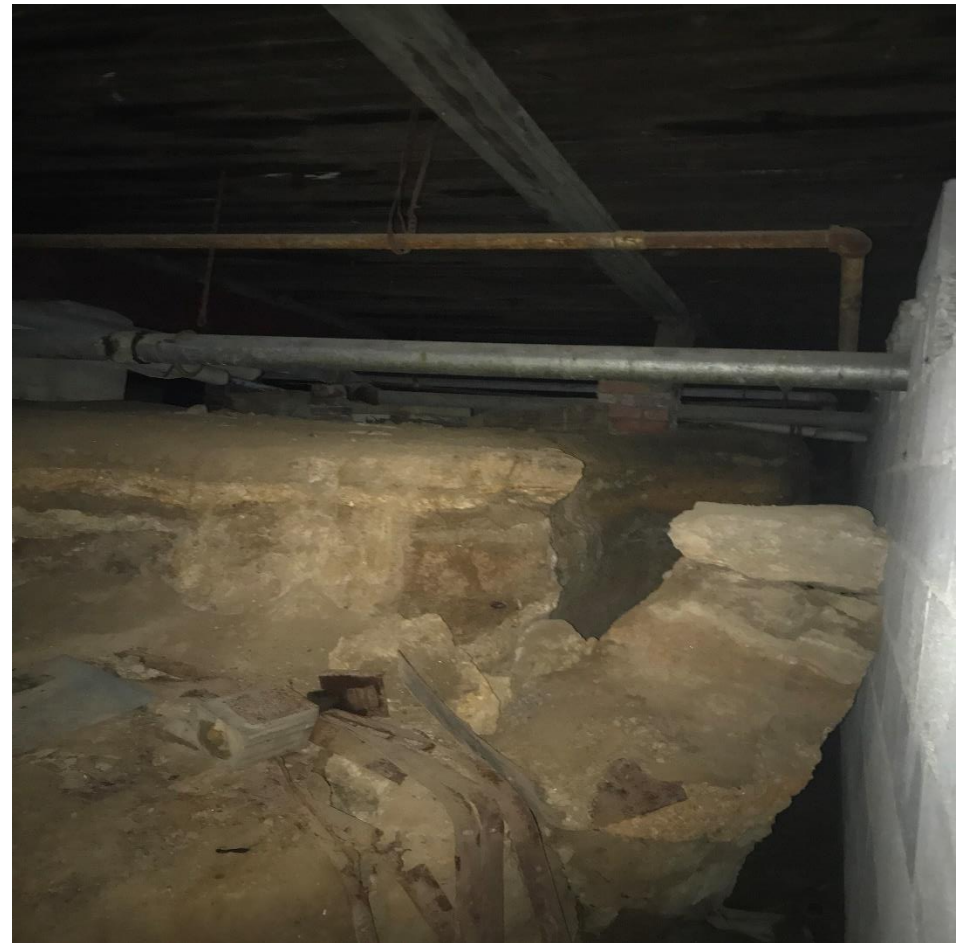
Photo 14 – Pipe Missing Insulation in Crawlspace

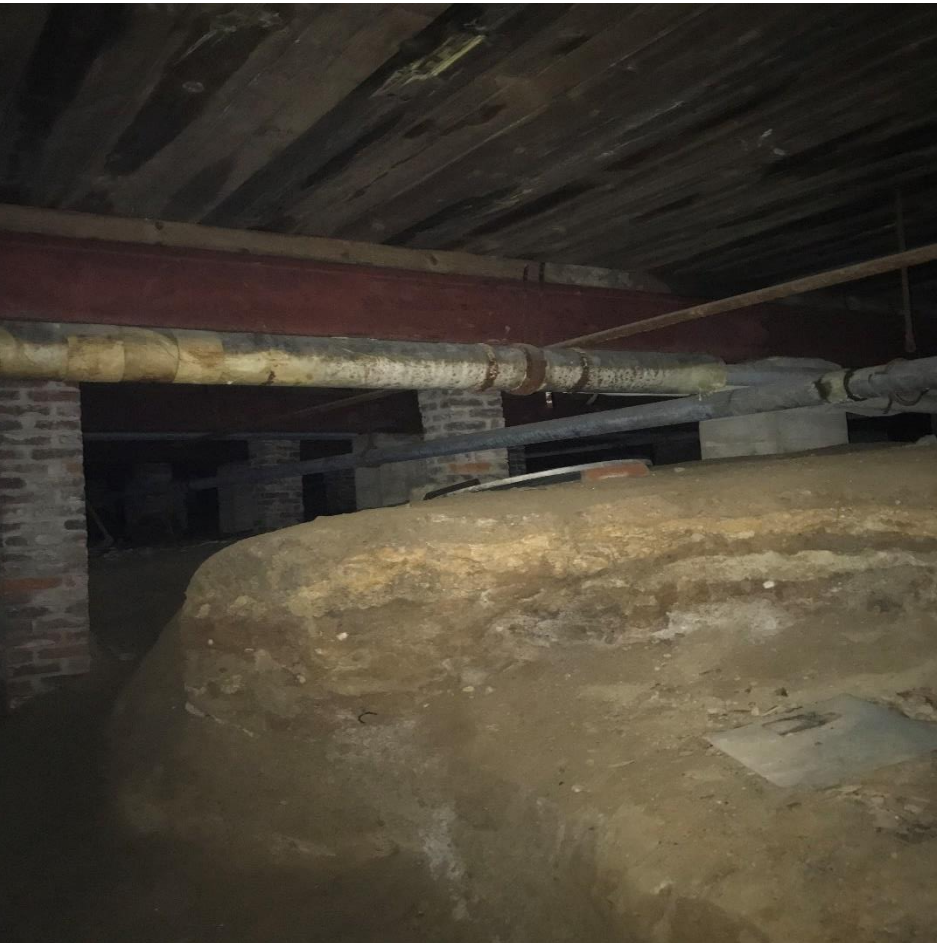
Photo 15 -- Poor Condition Pipe Insulation in Crawlspace

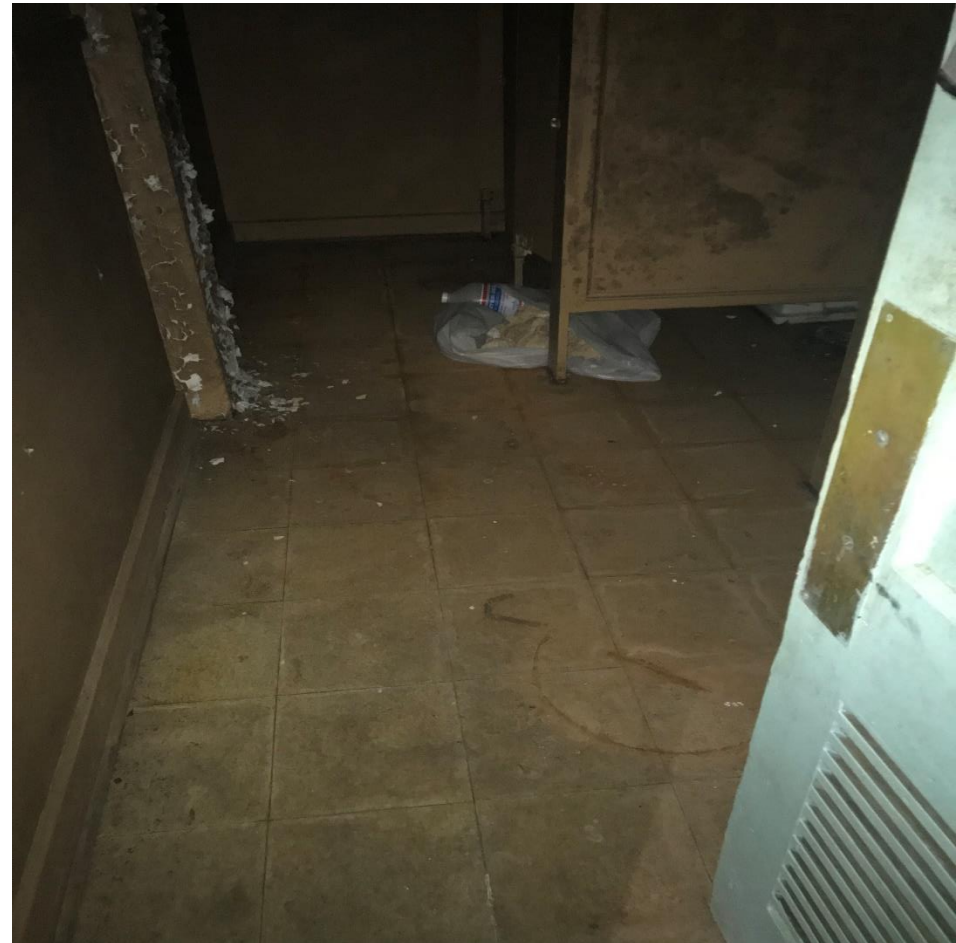
Photo 16 – Asbestos 9”x9” Floor Tile in Bathrooms

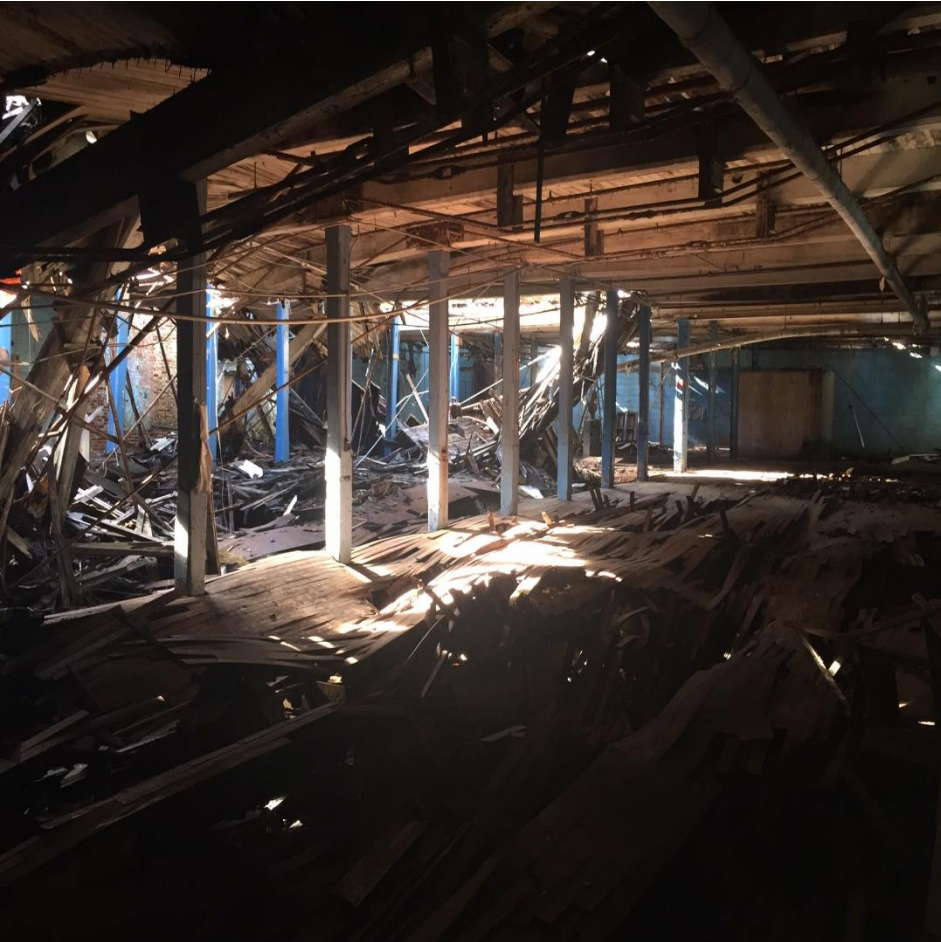
Photo 17 – Collapsed Ceiling/Floor Area on Ground Floor
